Manhole Inspection Summary

Manhole # S4700_002MH

Location Address: **Saint Lo Dr**

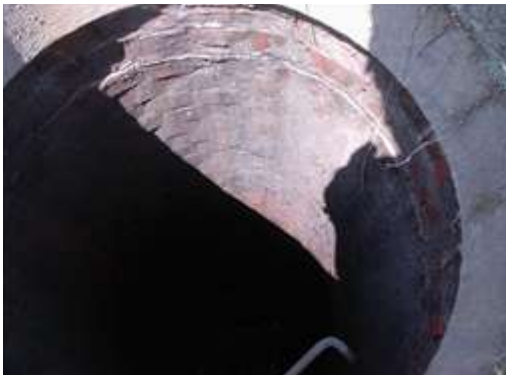
Defect 1

infiltration

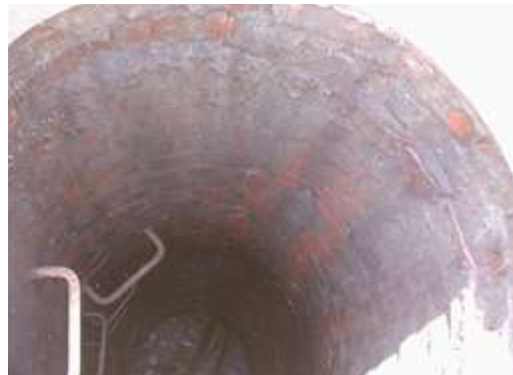
Defect 2

frame leaks

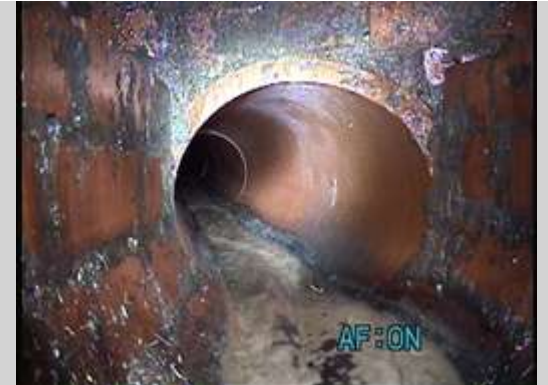
12 O'Clock Outflow

10 in. Circular Gravity Sewer
Pipe Out @ 12 O'Clock

Pipe Height: **10.8** (in.) Rod and Bar (Angled)
Pipe Material: **Clay** ☐ Pipe Lined
Invert Depth: **21.05** (ft.) Flow Characteristics: **Fast**
Deposits: ☒ None ☐ Mud ☐ Sludge ☐ Debris ☐ Grease
Silt Depth: (in.) Deposits Extent:
Infiltration: **None** Pipe Seal Cond: **Sound**

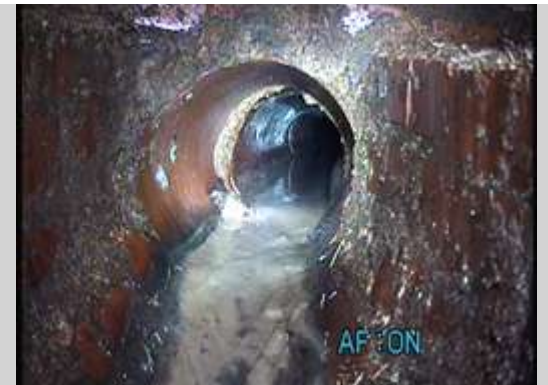
6 O'Clock Inflow

10 in. Circular Gravity Sewer
Pipe In @ 6 O'Clock

Pipe Height: **10.8** (in.) Rod and Bar (Angled)
Pipe Material: **Clay** ☐ Pipe Lined
Invert Depth: **20.70** (ft.) Flow Characteristics: **Fast**
Deposits: ☒ None ☐ Mud ☐ Sludge ☐ Debris ☐ Grease
Silt Depth: (in.) Deposits Extent:
Infiltration: **None** Pipe Seal Cond: **Sound**
